Bourne Leisure Ltd. Thermal Performance Measurement Report

May 2016

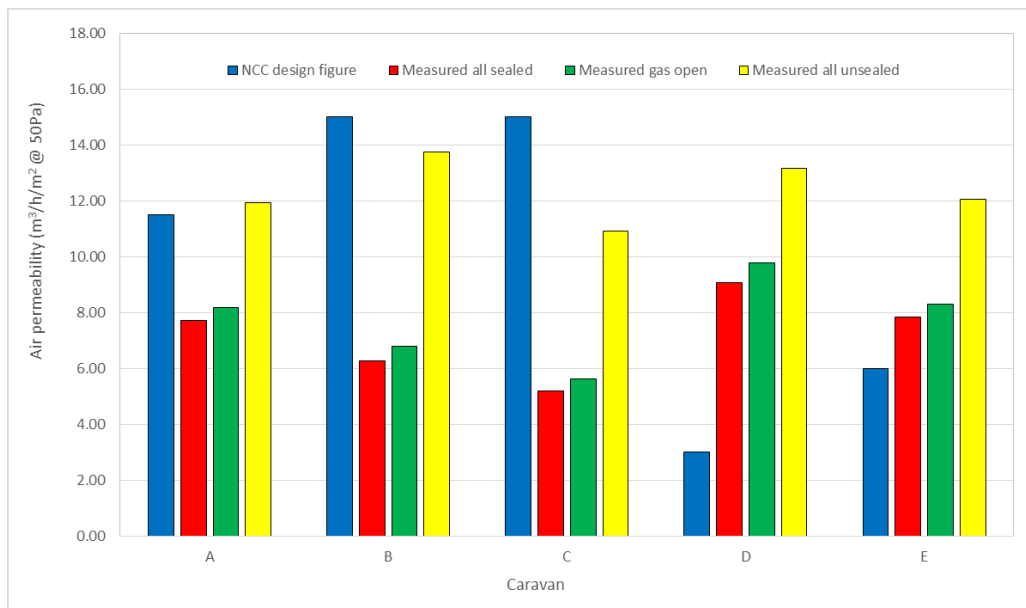
Figure 6 Comparison between the measured and design air permeability values for the test caravans.

- 27 For caravans, A, B and C, the measured air permeability values obtained when all of the purpose provided ventilation and gas drop out points are sealed are significantly lower than the design intent. For caravans B and C, this can be attributed to the fact that the manufacturers of these caravans claimed that no airtightness test had been undertaken on a suitably tested caravan within the NCC Energy Efficiency Calculator, so the air permeability figure used for the design intent was the default value of $15 \text{ m}^3/(\text{h} \cdot \text{m}^2) @ 50\text{Pa}$. The default figure contained within the NCC Energy Efficiency Calculator is artificially high to encourage manufacturers to undertake a pressurisation test on their caravans.

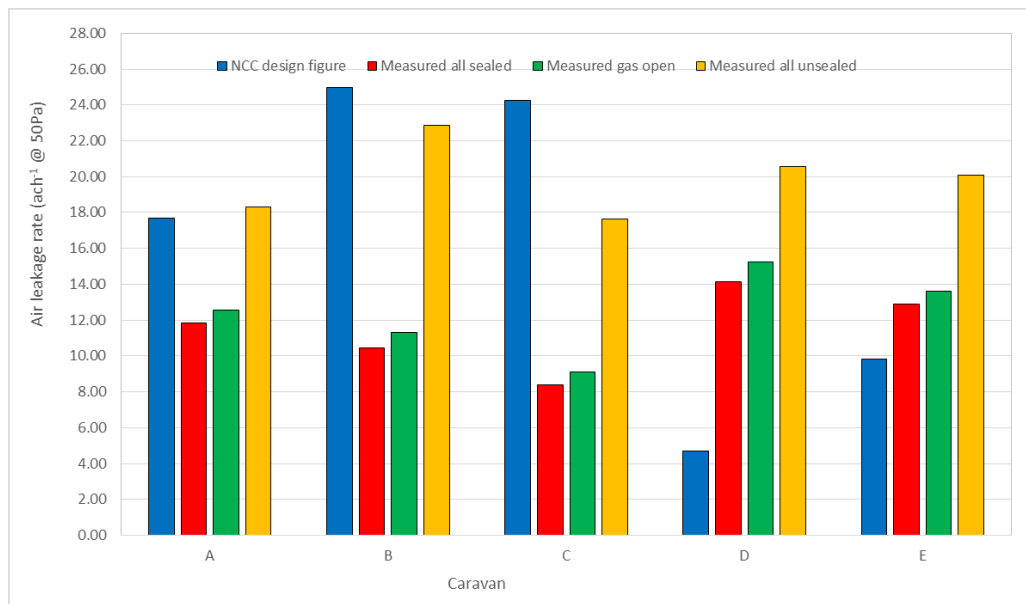
Figure 7 Comparison between the measured and design air leakage rates for the test caravans.

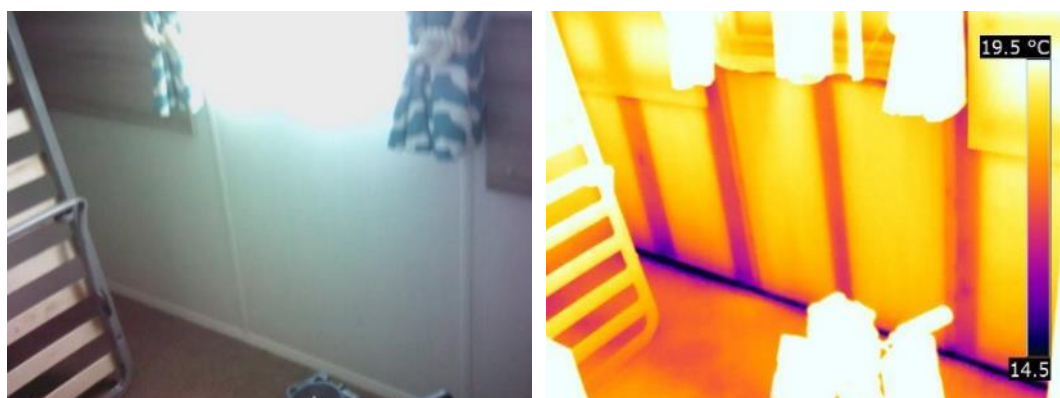
- At the vertical and horizontal studs used to construct the framing for the external wall where they penetrated through the insulation layer (see Figure 30). It is interesting to note that there are no horizontal farming members used in the construction of the external walls in caravan E (see Figure 31).

Figure 31 Lack of horizontal members in the external wall of caravan E.

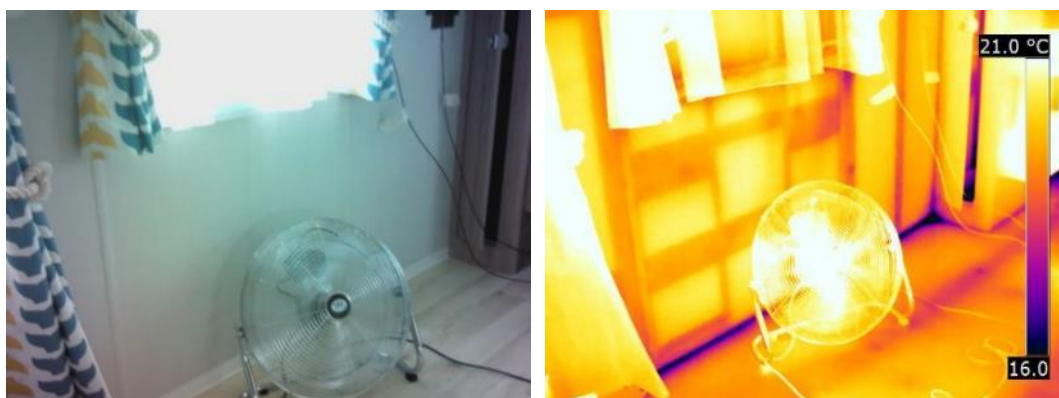
Figure 39 Thermal bridging below the kitchen/living area window in caravan E.

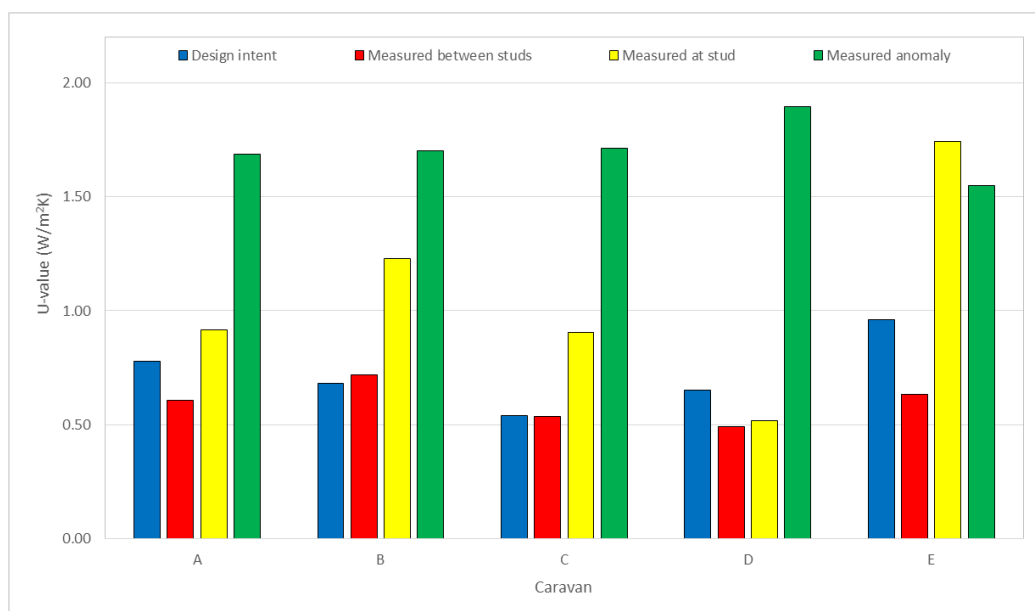
- 46 It is also clear from Figure 46 and Figure 48 that the *in situ* U-values measured at the external wall and roof anomalies are significantly higher than the design intent steady-state U-values. This can be attributed to the excessive thermal bridging that was observed at these locations. In the case of the external wall anomaly, the thermal bridging was caused by the insertion of additional timber at this location to enable the mounting of an external aerial. With respect to the ceiling anomaly, removal of the ceiling extract grille revealed either a lack of, or the omission of insulation surrounding the extract grille (see Figure 51).

Figure 46 Average *in situ* external wall U-value for each test caravan.

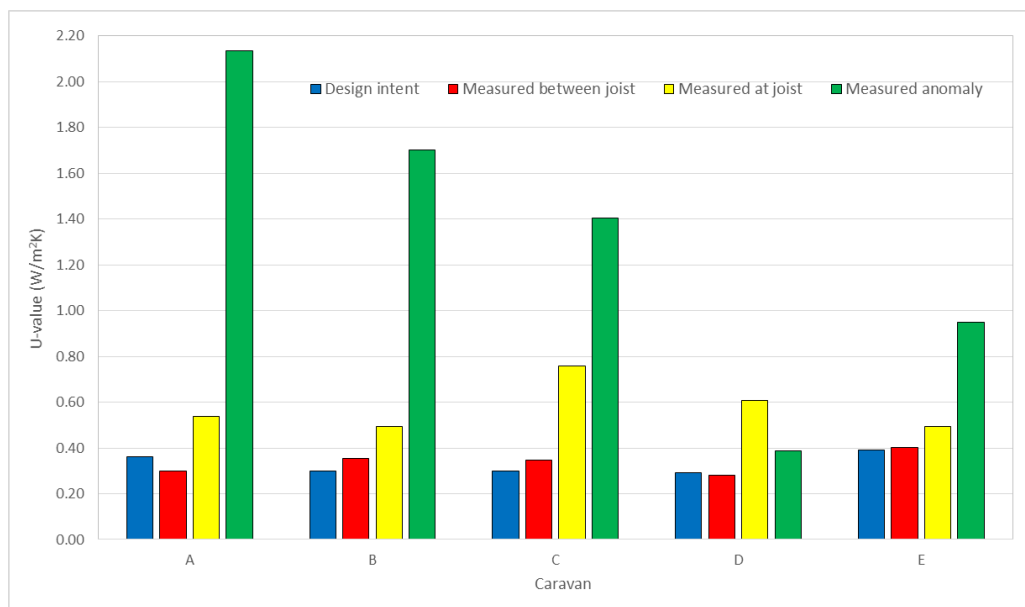
Figure 48 Average *in situ* roof U-value for each test caravan.

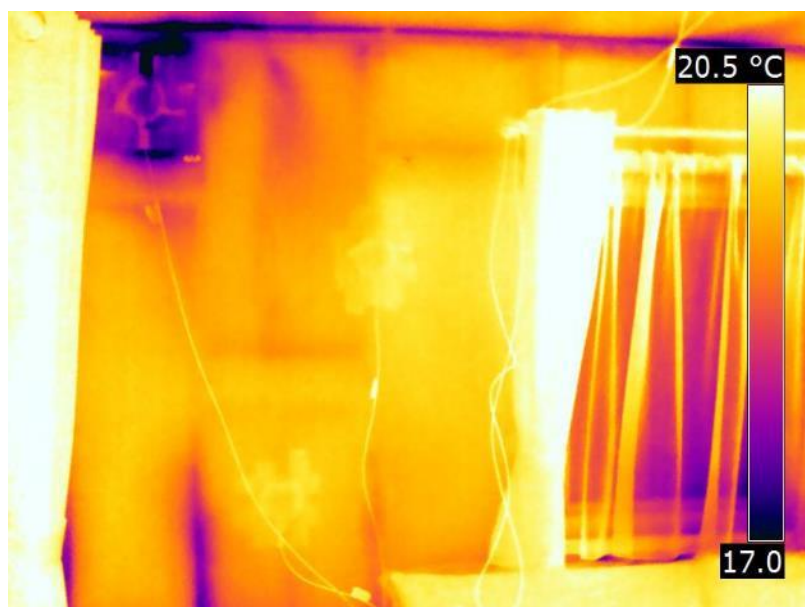
- 45 In terms of the measurements undertaken at the studs and joists, the analysis reveals that in the majority of cases the measured *in situ* U-values are considerably higher than the design intent steady-state U-values. This is to be expected, as the timber studs and joists represent a thermal bridge through the fabric of the test caravans. However, in the external wall of test caravan D, the measured *in situ* U-values at the stud were lower than the design intent steady-state U-values and only marginally higher than the value obtained between the studs. This suggests that this HFP was not accurately positioned directly across the stud within this caravan. An analysis of the thermal image undertaken once the HFPs were installed within test caravan D reveals that this HFP was positioned slightly off-centre to the stud (see Figure 50).

Figure 50 Location of HFP 2 in test caravan D.

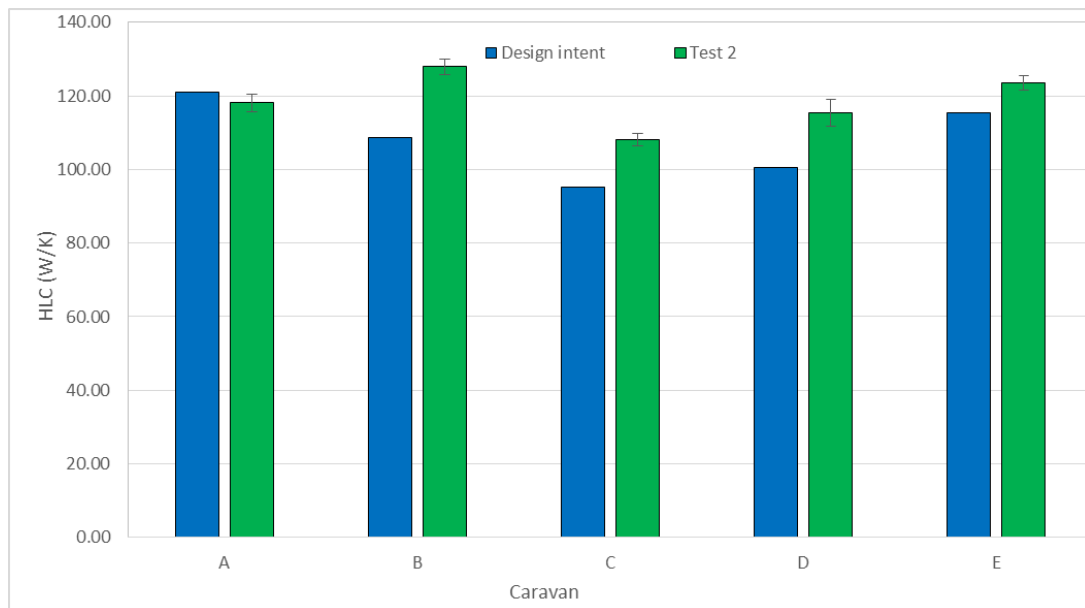
- 52 As can be seen from Figure 56, in the majority of cases, the measured HLC obtained from Test 2 is greater than the design intent HLC, indicating a building fabric performance gap. The only instance where this is not the case is in caravan A, where the measured HLC is comparable to the design intent HLC. However, such a comparison can be misleading, as the design intent HLC figure incorporates background ventilation heat losses which have been calculated based upon the air permeability figures incorporated with the NCC calculator. In all of the tested caravans, a difference was observed between the air permeability figures measured and those inserted into the NCC calculator and, in some cases, this difference was considerable.

Figure 56 Comparison of the electric coheating test results with the design intent HLCs.

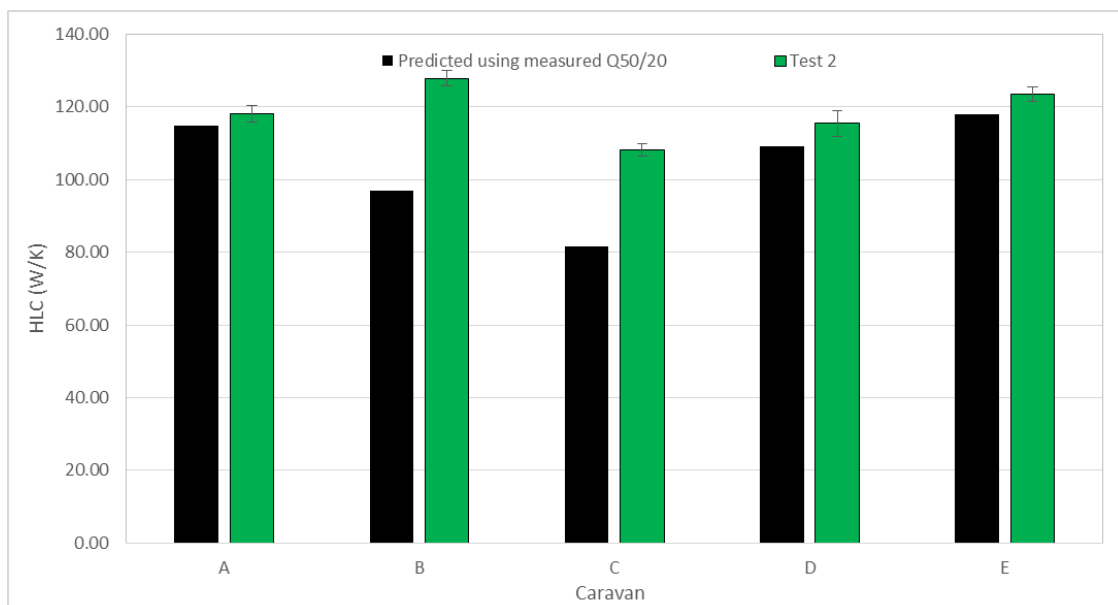
- 53 A more appropriate comparison would be to compare the results from Test 2 with the predicted HLC, as is illustrated in Figure 57. This comparison shows that in all of the test caravans, the measured HLC obtained from the electric coheating test is greater than the predicted HLC, indicating that a building fabric performance gap exists within all of the test caravans. Closer analysis of the data reveals that the scale of the gap varies considerably between the various test caravans. For caravans A, D and E the size of the gap is small (3.3 W/K, 6.2 W/K and 5.5 W/K, respectively). However, for caravans B and C, the size of the gap in performance is considerable. For caravan B the measured HLC is 31.0 W/K greater than predicted and for caravan C the measured HLC is 26.6 W/K greater than predicted. This represents an increase in HLC of just over 30% for both of these caravans.

Figure 57 Comparison of the electric coheating test results with the predicted HLCs.

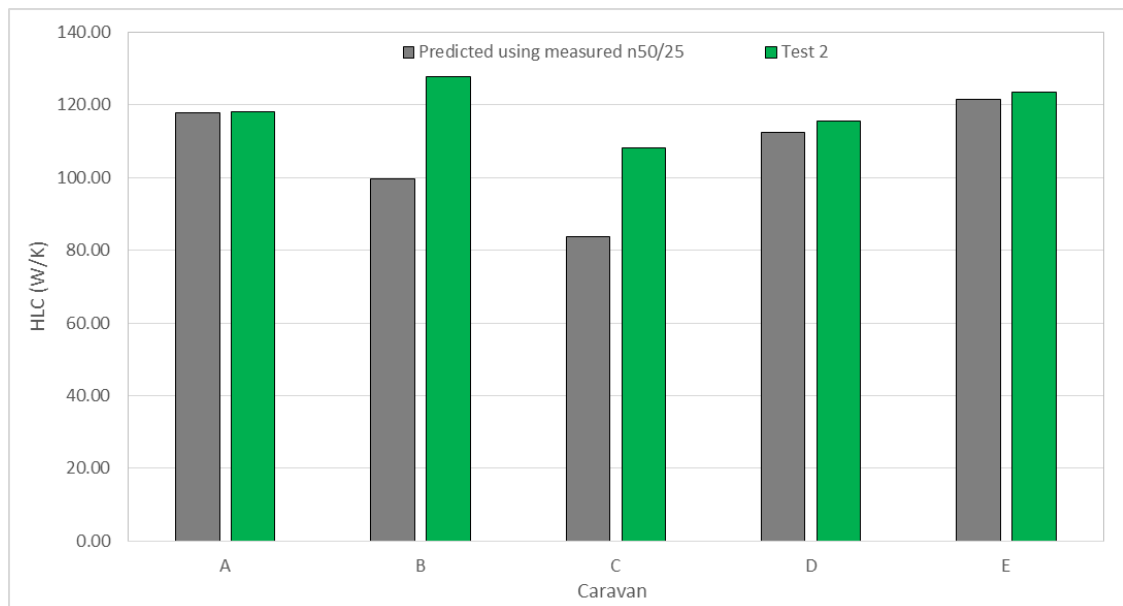
can be seen from Figure 58, the measured HLC is much greater than the predicted HLC for test caravans B and C (28.2 and 24.5 W/K, respectively). For caravans A, D and E the difference between the measured and predicted HLC is marginal (0.4, 3.0 and 2.1 W/K respectively). However, it should be noted that test caravan A is larger than all of the other test caravans and was not subject to any CO₂ tracer gas decay measurements. Therefore, it may be that the divisor of 25 is not appropriate for this test caravan. Despite this, the results obtained for test caravans A, D and E appear to be counterintuitive, particularly when the results of the heat flux density measurements are considered. As the calculated *in situ* U-values were in the main much greater than the design intent steady-state U-values, the measured HLC's for these caravans would have expected to have been much greater than the predicted HLC's, rather than being comparable, if these U-values are deemed to be representative of the construction as a whole. If this is the case, this would add weight to the suggestion that the '*rule of thumb*' divisor of 25 is likely to be too low. However, as previously discussed, this may not necessarily be the case, as the *in situ* U-values of the main elements of the building fabric are likely to be lower than those calculated from the heat flux density measurements.

Figure 58 Comparison of the electric coheating test results with the predicted HLCs using $n_{50}/25$.

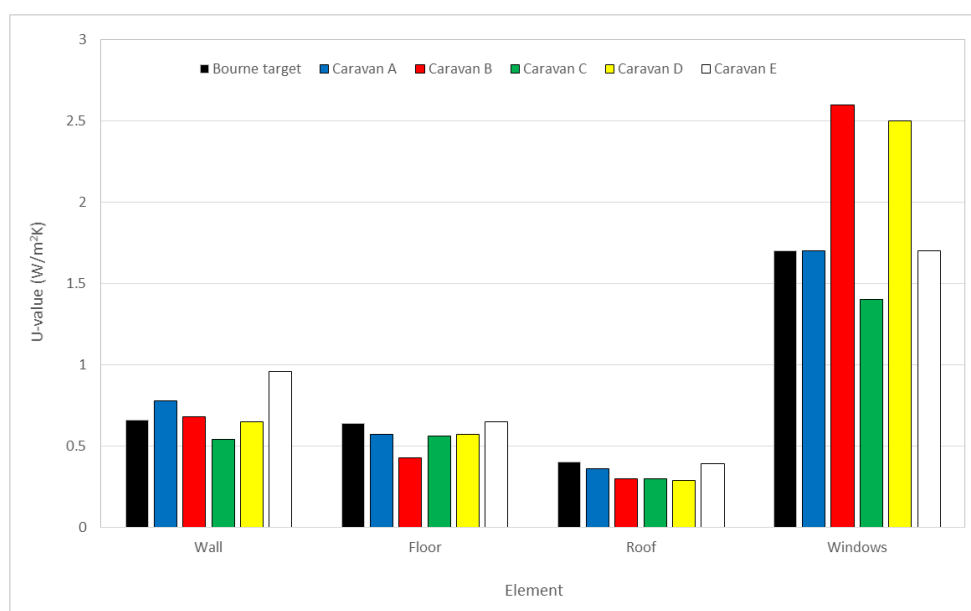
Figure 60 Comparison between the design intent U-values and the Bourne specification.

- 57 As can be seen from Figure 60, four of the five caravans failed to meet one or more elements of the U-value specification, resulting in only the caravan meeting all of the U-value specifications (caravan C). The caravans that failed to meet the greatest number of elements of the specification were caravans B & E, which failed to meet 50% of the U-value specification. In terms of the individual fabric elements, although all of caravans met the roof U-value specification, caravans A,

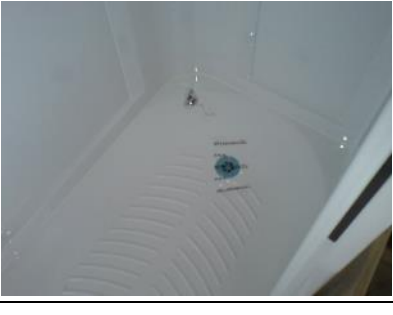
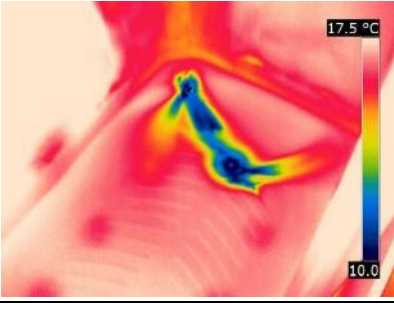
Room – Bathroom Span – 7.5 °C Daylight visible through a gap at the waste pipe penetration – a photo of this detail from beneath is shown at the end of this section.

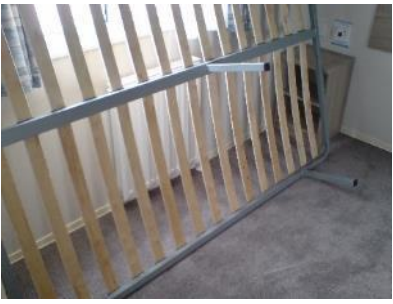
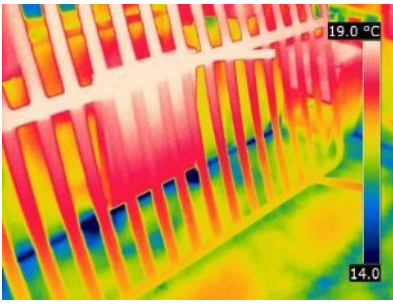
Room – End Bedroom Span – 5 °C Under depressurisation, at higher pressures, the carpet in this room was seen ballooning upwards; air can be seen moving beneath the carpet in the thermal images.
